October 6, 2015

This letter is in response to the email you sent to Mr. Steve Ortiz, the General Manager of Sterigenics Santa Teresa facility on September 24, 2015. Following are the responses to the questions regarding the ethylene oxide (EO) release at the Santa Teresa facility on September 14, 2015.

SPILL AND RELEASE INVESTIGATION REPORT

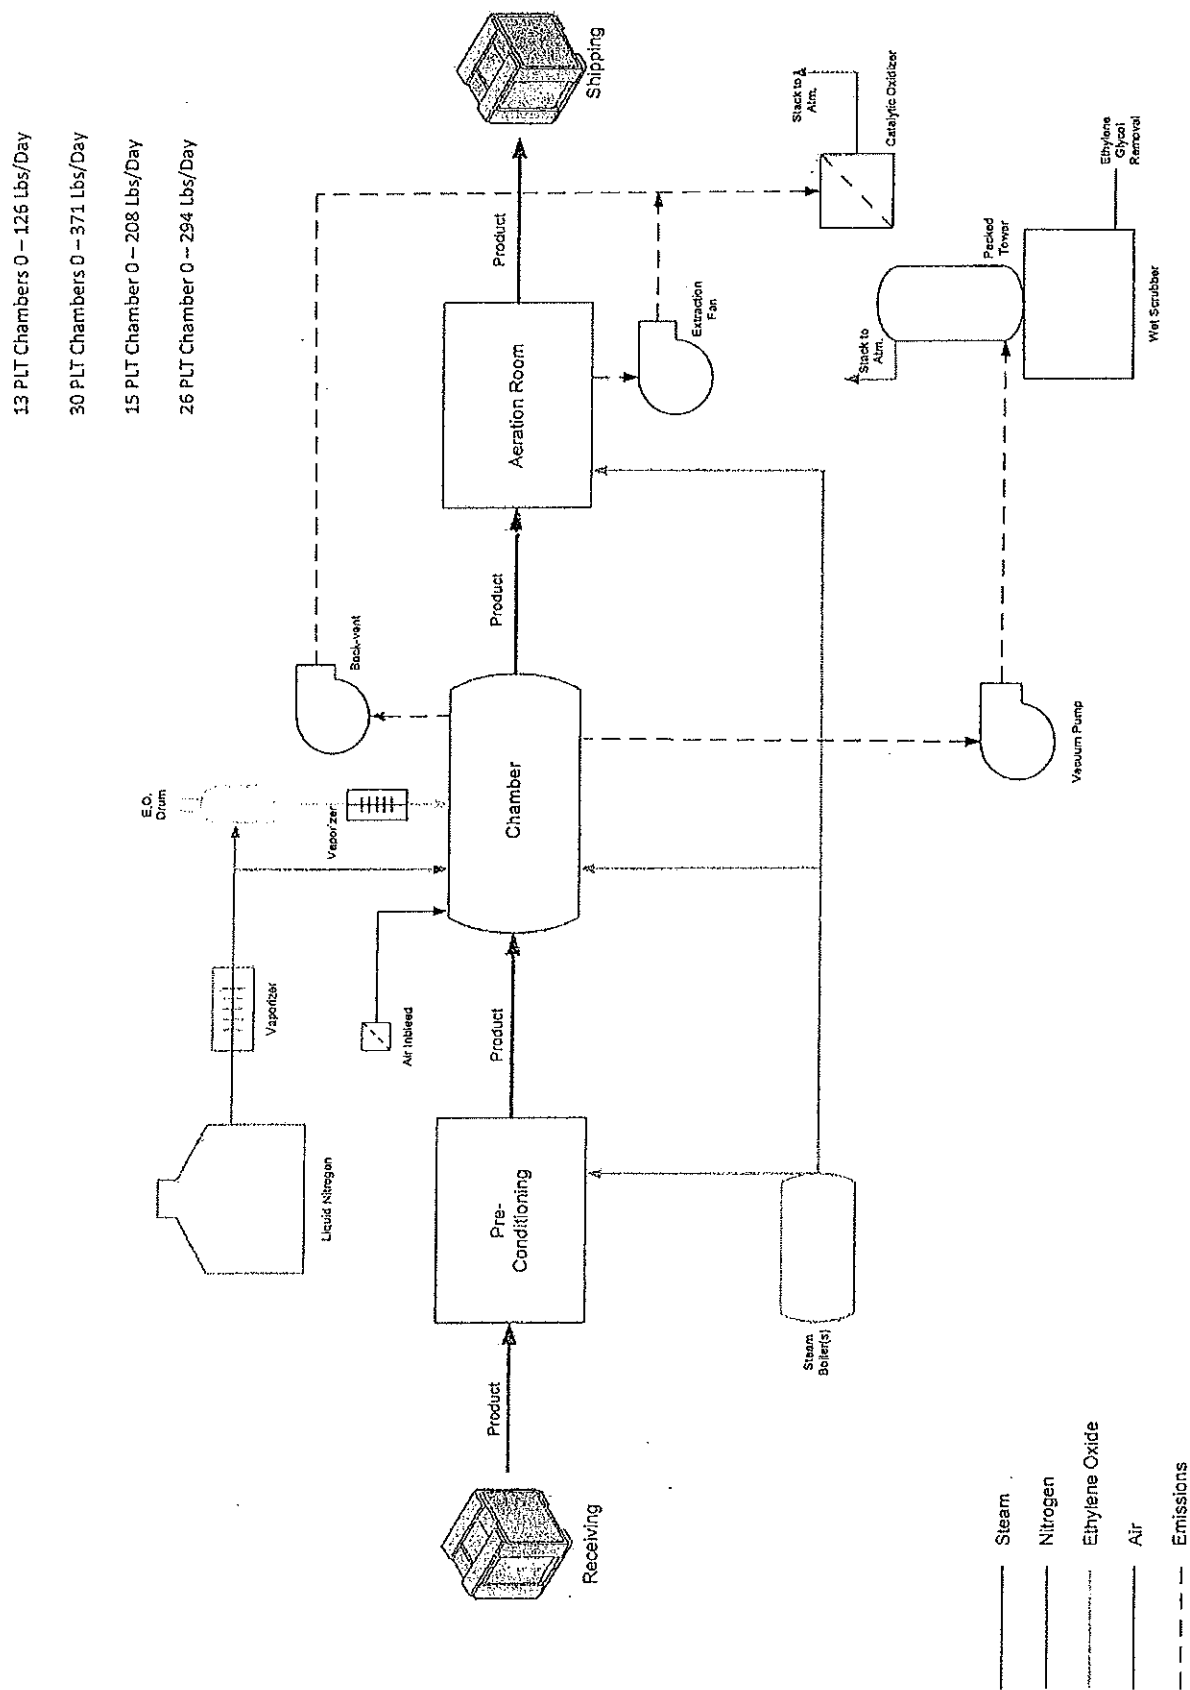
Sterigenics Process Flow Diagram

Sterilization Chamber #2 was involved in the incident. For further information, please refer to the attached process flow diagram.
